April 1, 2026

Re: Updated Site Assessment/Observations – The Oaks Residential Development
Palmyra, Lebanon County, Pennsylvania
ALW Project No. 2024-09C

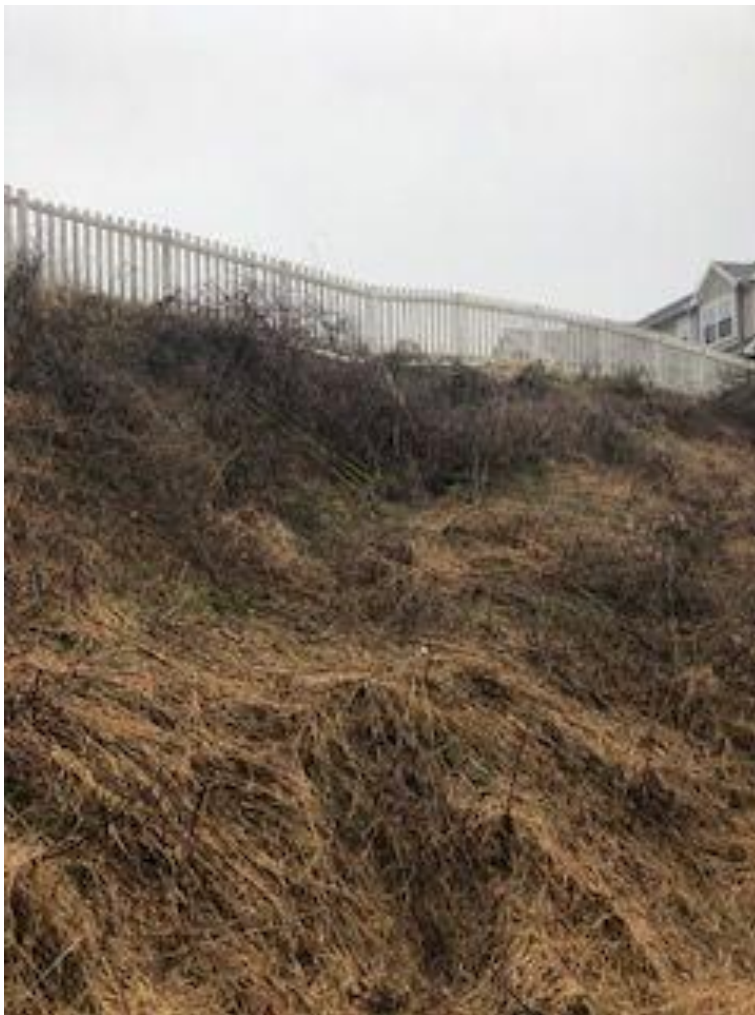
- As requested, we also provided assessment of the steep slope above SWM Basin #1 which forms the rear of several houses at the terminus of Pin Oak Street. The steep slope is mostly vegetated and includes a fence along the top of slope. In general, steep slopes such as this one, which are in close proximity to structures or are used as structural support (holding up parking lots, decks, patios, etc.) are not recommended to be constructed at grades steeper than 3:1 (3 feet horizontal by every 1 foot of vertical rise). It appears that the constructed slope in this area is steeper than 3:1 (appears to be 2:1 or steeper). As such, there are certainly some general concerns relative to the ongoing maintenance of the slope.

A detailed review of the slope conditions (toe, crest, and along the embankment) on March 11, 2026 indicated that the slope appears to be stable and in good condition. There is no indication of active or past slope (soil) movement and there are no obvious or substantial surficial erosion concerns at this time.

- (2) The top of the slope is marked with a fence, which covers the majority of the limits of the top of the slope. On the downslope side of the fence, we noted a mowed walking path appears to be maintained. This leaves the “crest” or top of slope edge with very little vegetative cover. Surface water runoff above the slope generally drains in the direction of the slope or adjacent to it. We recommend that mowing/maintenance of the small grass strip on the downslope side of the fence be ceased. The top of the crest is a critical point in the overall slope construction. Surface water runoff that can infiltrate into the top of slope area may lead to short and longer-term problems with the overall integrity of the slope with time. Vegetating this area to the edge of the top of slope is preferred will help reduce erosion and stability concerns. Plantings along the edge of the top of slope should not be completed at one time so as to reduce the overall disturbance along the top of the slope during a single season. We suggest staging the plantings/vegetative cover in this area of the slope over several seasons. See the attached **Site Photographs** for additional details.

Photograph No. 1 – Steep Slope behind residences at Pin Oak Street. Although no visible in this photograph, there is a small mowed or maintained strip at the top of this slope on the “outside” of this fence.

cover also assists in reducing surface water collection and concentration along the slope. Removing the vegetation along the embankment would subject the slope to increased risks of surface failures (soil sliding and erosion) and is not recommended. We recommend maintaining much of the vegetation in its current condition. Open areas along the embankment, without vegetation, should be planted with small plants/shrubs, grasses, ground-cover type plants. The Pennsylvania Department of Conservation and Natural resources along with the US Department of Agriculture, have numerous available resources concerning slope stabilization using vegetative cover. Further, the Lebanon County Conservation District may also have local listings of ideal native flowers, plants and shrubs that can be incorporated.

- (1) Rodent holes and ground hog burrows were observed throughout the embankment. In general it is not recommended to allow small rodents/pests to use the embankment for tunnels/burrows. Burrows and tunnels weaken the face of the slope causing additional erosion over time and also create areas/repositories for water collection, which in turn, can accelerate the weakening of soil conditions along the face of the slope. We recommend closing of all animal burrows/tunnels observed on the slope. This process should be repeated, as needed, annually.

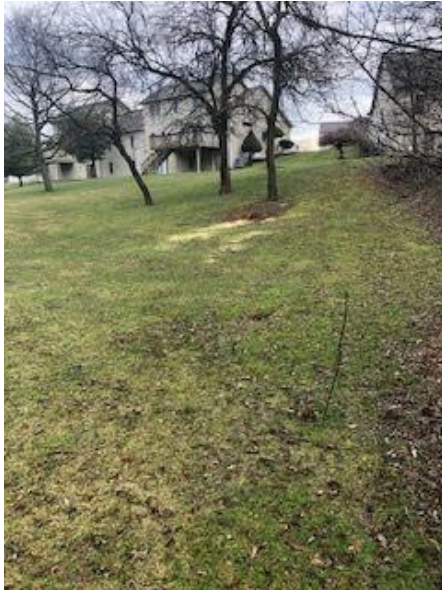
Similarly, beyond a small cluster of trees to the rear (north) of 41-43 Hickory Street, we observed an area of irregular subsidence with numerous small openings and depressions at the ground level. Please see attached **Site Photographs** and **Site Features Plan**. Some evidence of loose or intact bedrock could be observed within several of these open depressions. Generally, the open depressions are not several large (<1 foot in diameter); however, the “clustered” nature and orientation of these features in a group may indicate a larger area of soil erosion occurring in the subsurface. We recommend that this area be closely observed from season to season through the year, noting any increased subsidence or additional openings at the ground surface.

Photograph No. 2 – Photograph of an area of subsidence, openings and depressions at the ground surface that appear to be grouped or clustered and has recently formed according to the HOA.

3. Open/active subsidence features along the rear (north) common or drainage and utility easement areas should be closely monitored from season to season, noting any significant changes at the ground surface. As discussed, the most economical solution at this time would be to plug/fill these various openings with compacted clay soils. We do not recommend the use of sand, rocks, concrete, topsoil or other materials as they will only cause increased infiltration of water into the openings in the subsurface and eventually lead to additional erosion. Placing compacted clay materials into these openings will help to direct surface water past or beyond these areas. Please note, the outlined mitigation is not a long-term solution to possible or eventual deeper sinkhole development. The recommendations provided are meant to represent short-term or basic maintenance measures that are both economical and practical to the HOA when attempting to address mitigation of these sensitive areas of the property. Further, openings such as those observed, represent safety concerns.

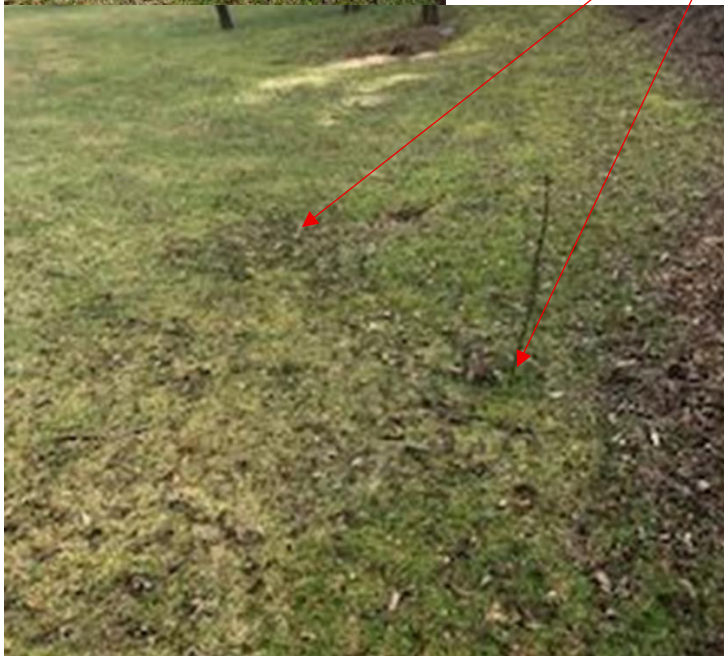
Closed and open depressions were observed throughout this area
