November 14, 2024

Re: Site Assessment/Observations – The Oaks Residential Development
Palmyra, Lebanon County, Pennsylvania
ALW Project No. 2024-09B

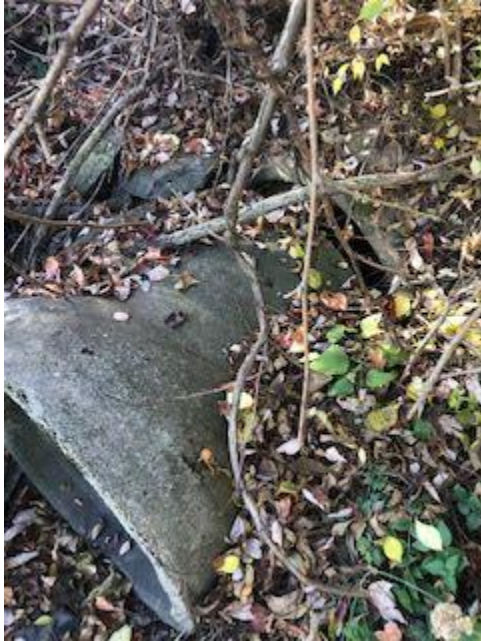
- At SWM Basin #3, it was noted that a 36-inch CMP discharges into the basin from Apple Blossom Lane. The end piece of the concrete discharge pipe has settled and separated from the main pipe alignment (See Photograph No. 1). The end piece of pipe does not appear to be damaged and no erosion was obvious around or beneath the discharge pipe. Although the pipe does not currently appear to be significantly disruptive to water flow, the displaced piece of pipe may cause irregular flow of stormwater exiting the pipe into the basin, particularly during heavy storm events. This condition should be periodically monitored. Should erosion begin to occur around or beneath the end of the pipe, it may be necessary to reconnect or reattach the end section of the CMP.

Photograph No. 1 – Separated end section of 36-inch CMP at SWM Basin #3

1. Although no immediate concern was noted at this time, SWM inlets and alignments should be properly maintained.
2. The 36-inch CMP discharge into SWM #3 may need eventual reattachment of the end section of pipe. Although not considered an immediate concern, should future erosion occur beneath or around the end of the pipe, it may be necessary to reconnect the CMP end section. The approximate costs of re-attaching this end section is anticipated to be less than \$1,000.00.

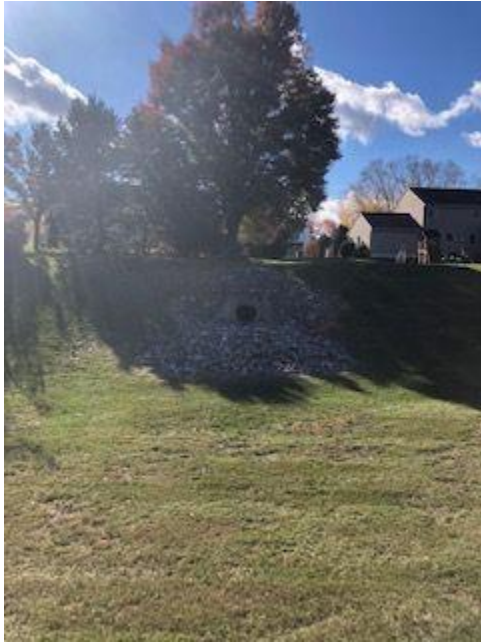
above the end wall. Please note, that the existing condition does not match the design plans, which likely indicates that rip-rap placement occurred after the basin was completed. It appears that the ground surface in this area may have been experiencing erosion at some point in the past. It also appears that the ground surface may have been graded in a way as to create a subtle swale between Lots 51 and 52 in the direction of the head wall.

Photograph No. 2 – Photograph of end wall at SWM Basin #3 and rip-rap above concrete end wall.

4. The rip-rap stone bed placed above the end wall should be eliminated since it is acting to collect and funnel water into the top of the end wall. Some re-grading will be needed in this area as well to convey water away from the top of the end wall. Stabilization of the ground surface should be performed to re-establish grass along the top of the embankment throughout this area. We recommend this work to be performed within a 1-2 year time frame. The approximate costs of these corrective measures are anticipated to be on the order of \$5,000.00.

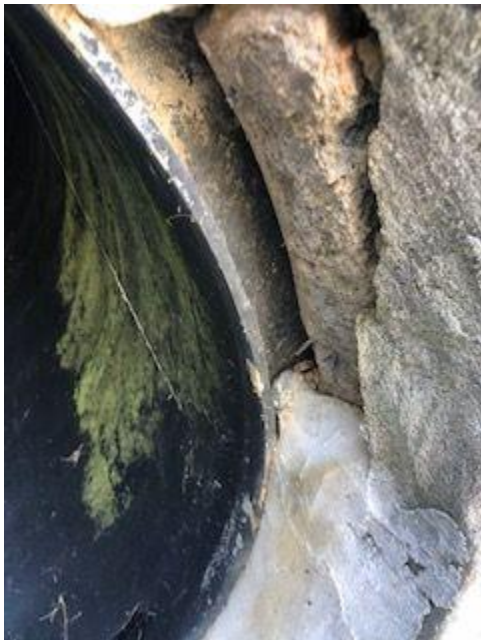
At the time of our site visit, we observed that the end of the PVC pipe exiting the end wall is becoming separated. This separation has left a gap between the pipe and concrete end wall. Water exiting the pipe is flowing into the opening around the pipe causing undermining of the pipe. The PVC pipe is beginning to crack and degrade along the edges, most likely due to “freeze-thaw” conditions as a result of excess water ponding around the pipe. Portions of the concrete end wall are experiencing the same damage. It is likely that water is flowing through the rip-rap above the head wall and contributing to erosion around the pipe. See Photograph Nos 2 through 5. We recommend correction of the ground surface condition above the end wall. Further, the gap or separation between the concrete end wall and PVC pipe should be closed/sealed to prevent water intrusion into and beneath the structure.

Photograph No. 3 – Close up photograph of separation of pipe and concrete at EW-2.

3. The end wall (EW-2) at SWM #3 has a disconnected PVC discharge pipe. The separation between pipe and end wall should be sealed/closed/parged in the near future. We recommend closing/sealing any cracks in the end wall as well. Recommend these repairs be performed within approximately 1-2 year time frame. The approximate costs of these repairs are anticipated to be less than \$5,000.00.

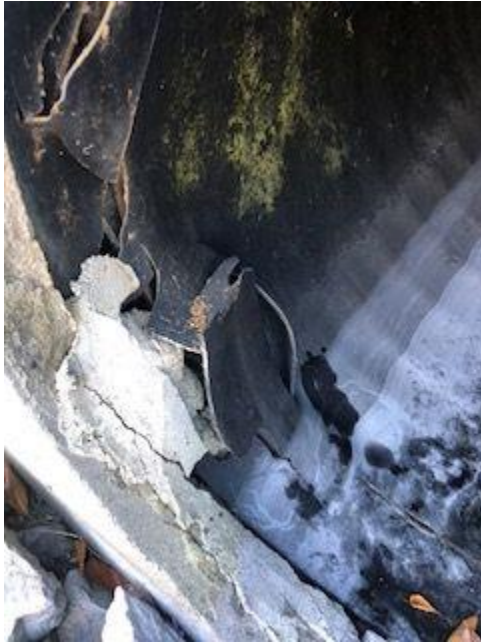
Photograph No. 4 – Additional view of damaged PVC pipe exiting EW-2.

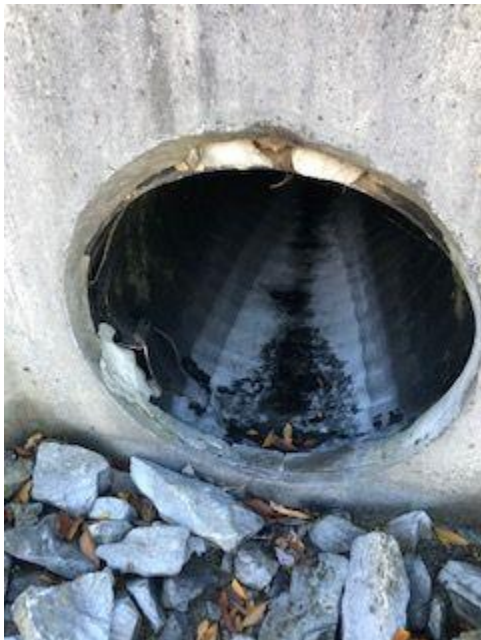
Photograph No. 5 – Additional view of end wall and discharge pipe at SWM Basin #3.

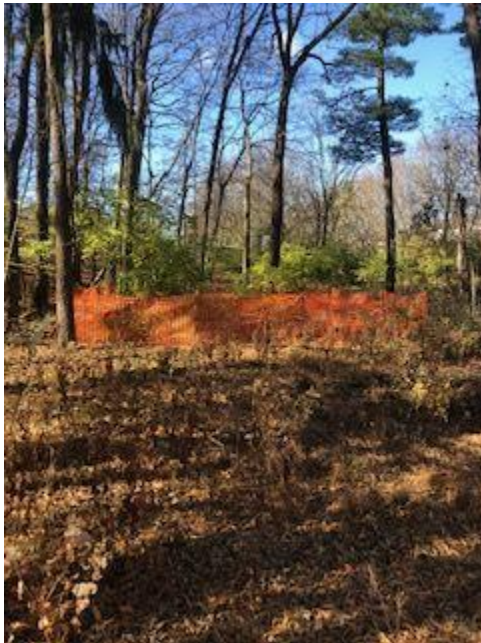
- There are currently a series of open/active sinkholes just beyond (to the north) SWM Basin #1 situated near the northeast corner of the Oaks development. The sinkholes can generally be grouped into three (3) features (See Photograph Nos. 6 and 7). These features are situated in a topographically low area just beyond the outflow pipe from SWM Basin #3. Bedrock outcrops were visible within the sidewalls of one or more of the features. It is likely that these features are “connected” in the subsurface. The open features are currently secured within orange safety fencing.

Photograph No. 6 – Safety fence surrounding sinkhole near SWM Basin #1.

5. The active/open sinkholes beyond SWM Basin #1 should remain secure with safety fence since these features may represent a liability consideration. The condition of these openings should be periodically monitored to ensure no significant ground loss is occurring that may jeopardize other surrounding site features. Consideration could be given to closing these features. Estimated costs for closure of the existing sinkhole features are unknown at this time and will vary based on the approach, equipment and materials utilized. If requested, additional consultation can be performed to ascertain costs associated with practical and economical solutions to restoration of these features.

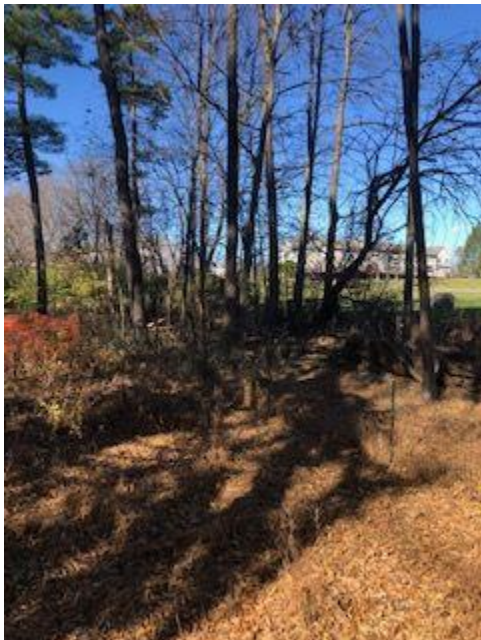
The open sinkholes are currently situated within the wooded drainage area just beyond the toe of the embankment for SWM Basin #3. No apparent concerns were noted during the site reconnaissance with respect to the embankment. We recommend periodic monitoring of these features and the adjacent ground surfaces to document that no significant ground loss is occurring over time throughout this area of the property. Restoration of these features may also be considered.

Photograph No. 7 – View of sinkhole area beyond SWM Basin #1. Neighboring residences in background.
