April 1, 2026

Re: Updated Site Assessment/Observations – The Oaks Residential Development
Palmyra, Lebanon County, Pennsylvania
ALW Project No. 2024-09C

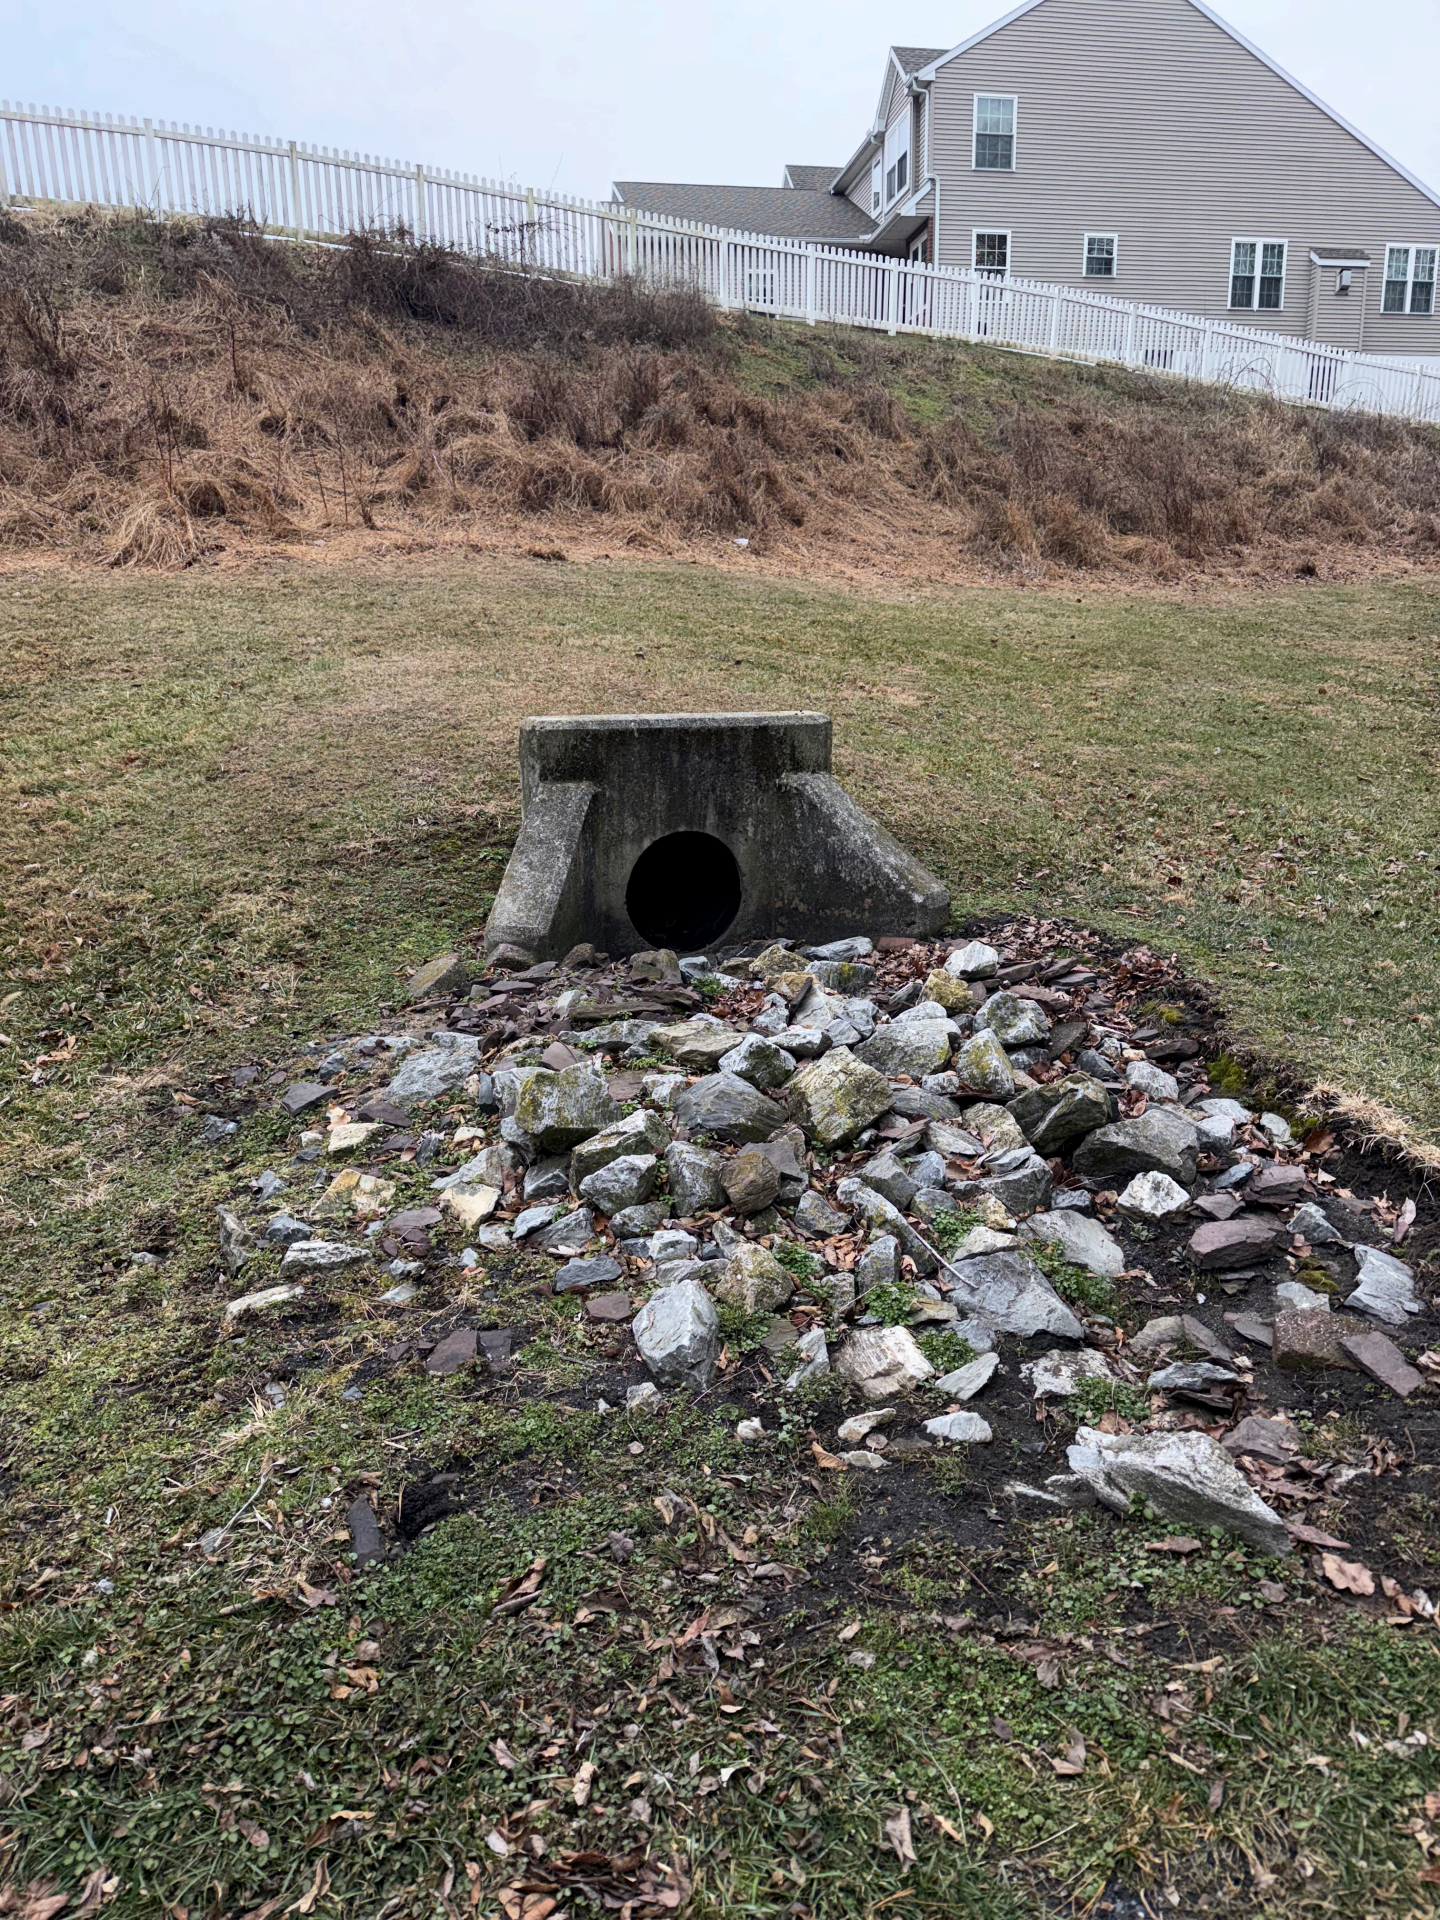
Photograph No. 1 – Steep Slope behind residences at Pin Oak Street. Although no visible in this photograph, there is a small mowed or maintained strip at the top of this slope on the “outside” of this fence.
