November 14, 2024

Re: Site Assessment/Observations – The Oaks Residential Development
Palmyra, Lebanon County, Pennsylvania
ALW Project No. 2024-09B

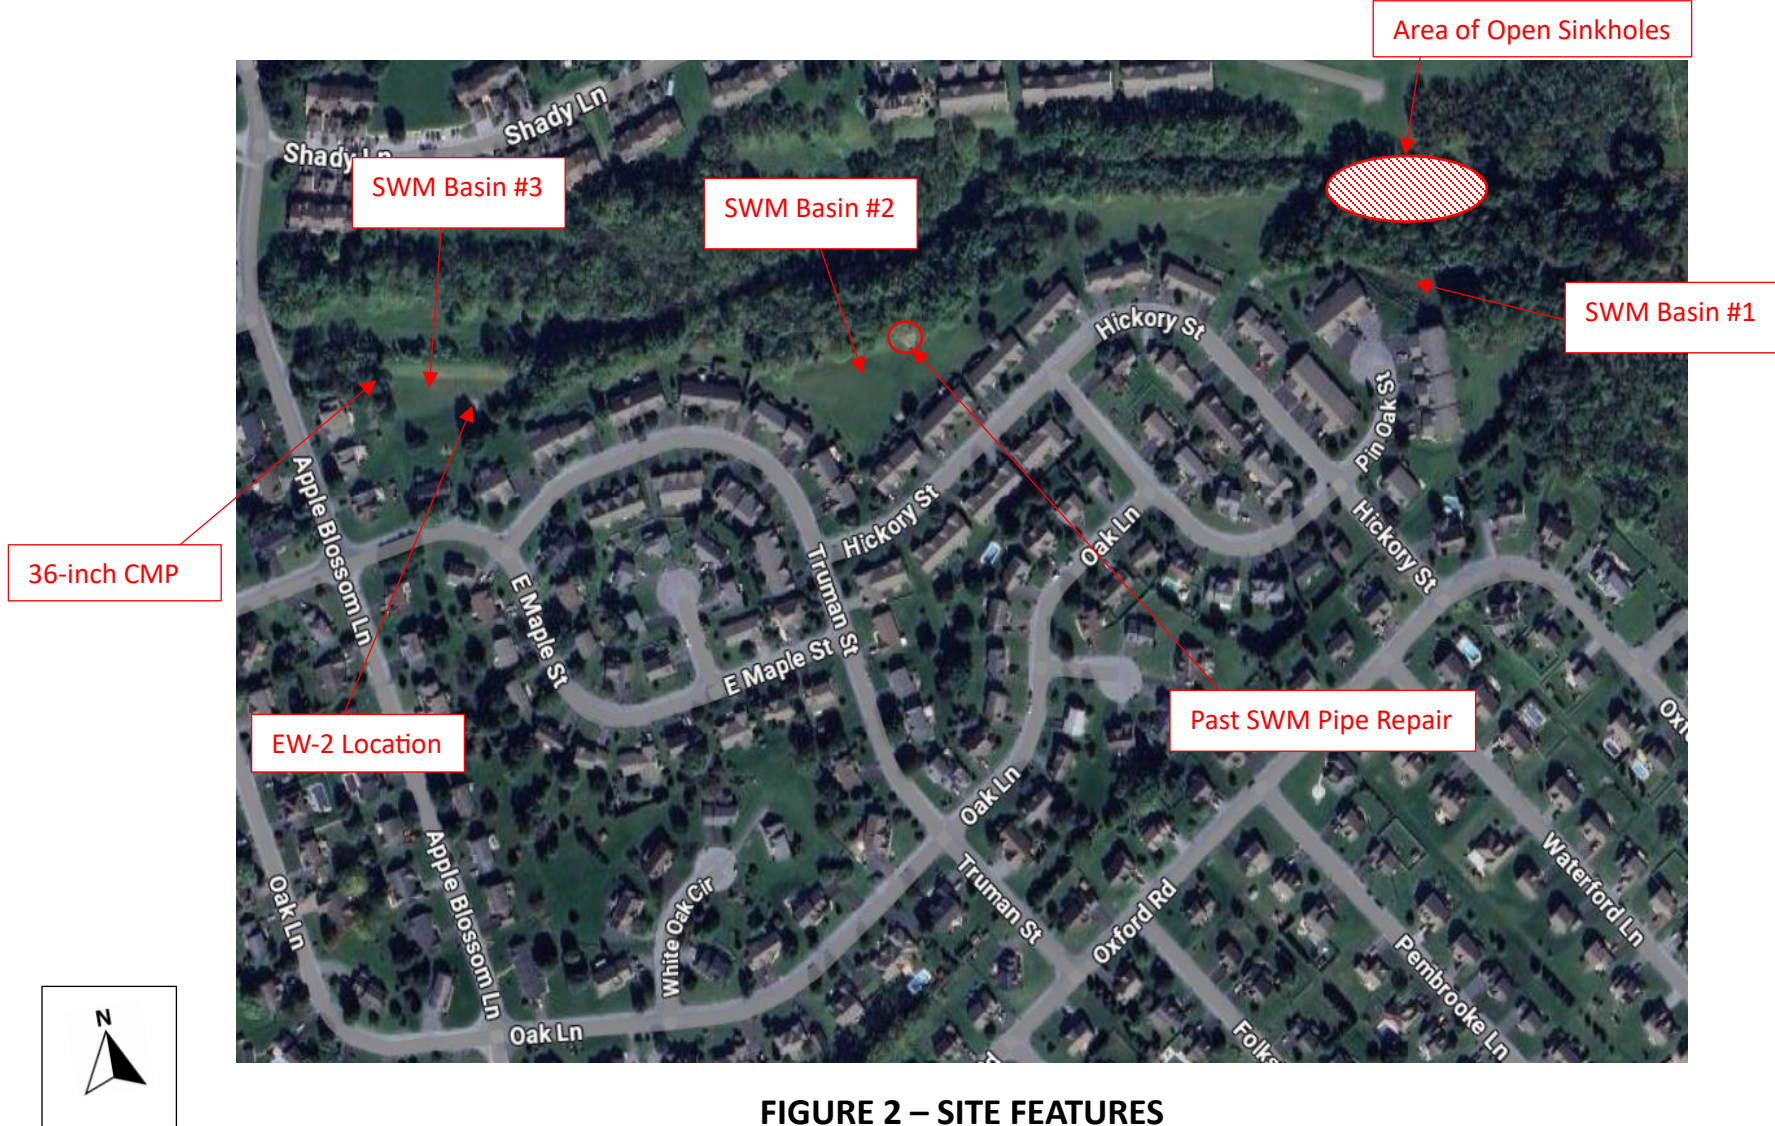
FIGURE 2 – SITE FEATURES

ALW Licensed Professional Geologist, Scott Summers visited the site on November 1, 2024. The site reconnaissance was performed with a member of the HOA and included traversing common areas and spaces throughout the development, including roadways, green spaces, SWM basins and drainage easement. **Figure 2 – Site Features**, has been included as an attachment to assist in providing a location to accompany descriptions provided herein. In summary, our site visit revealed the following key observations and findings:
